# Manhole Inspection Summary

Manhole # S53M\_\_040MH

Insp Date: **4/3/08 3:36 PM**

**Location** Address: **3300 Hudson sT**

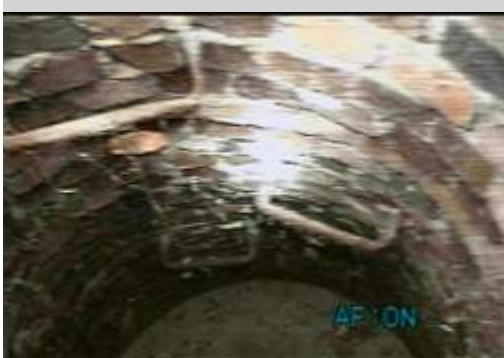
Defect 2

**Steps** Count: **3** Missing: **0** ☒ **Corroded**

corroded stairs

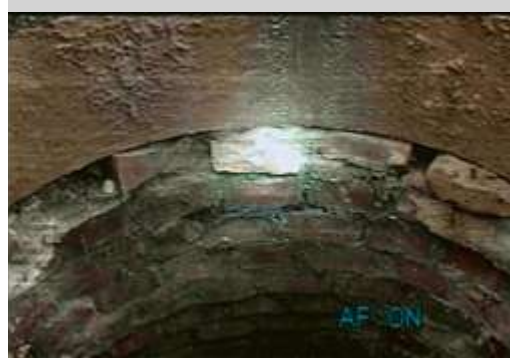
Defect 1

**Frame** Offset: **0** (in.) Condition: ☐ Sound ☐ Cracked ☒ **Leaks**

Condition: ☐ Sound ☐ Cracked ☐ Root Intrusion ☒ **Loose Brick** ☐ Deteriorated

Infiltration: ☐ None ☒ **Joint** ☐ Cracks ☒ **Mortar** ☐ Roots ☐ Wall

frame and chimney infiltration, loose brick in chimney

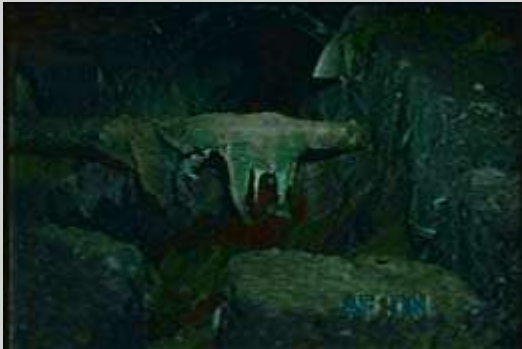
12 O'Clock Outflow

8 in. Circular Gravity Sewer  
Pipe Out @ 12 O'Clock

Pipe Material: **Clay** ☐ Pipe Lined

Invert Depth: **9.00** (ft.) Flow Characteristics: **Slow**

Deposits: ☒ None ☐ Mud ☐ Sludge ☐ Debris ☐ Grease

Infiltration: **None** Pipe Seal Cond: **Unknown**

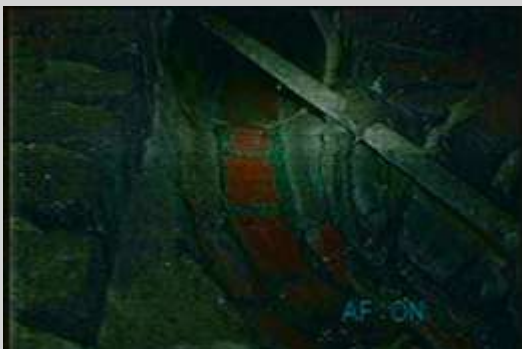
3 O'Clock Inflow

8 in. Circular Gravity Sewer  
Pipe In @ 3 O'Clock

Pipe Material: **Clay** ☐ Pipe Lined

Invert Depth: **8.00** (ft.) Flow Characteristics: **Slow**

Deposits: ☒ None ☐ Mud ☐ Sludge ☐ Debris ☐ Grease

Infiltration: **None** Pipe Seal Cond: **Unknown**
